260-IN.-DIA MOTOR FEASIBILITY
DEMONSTRATION PROGRAM (u)

STATIC TEST FIRING OF MOTOR 260-SL-2
FINAL REPORT

NASA CR-54982

25 MARCH 1966

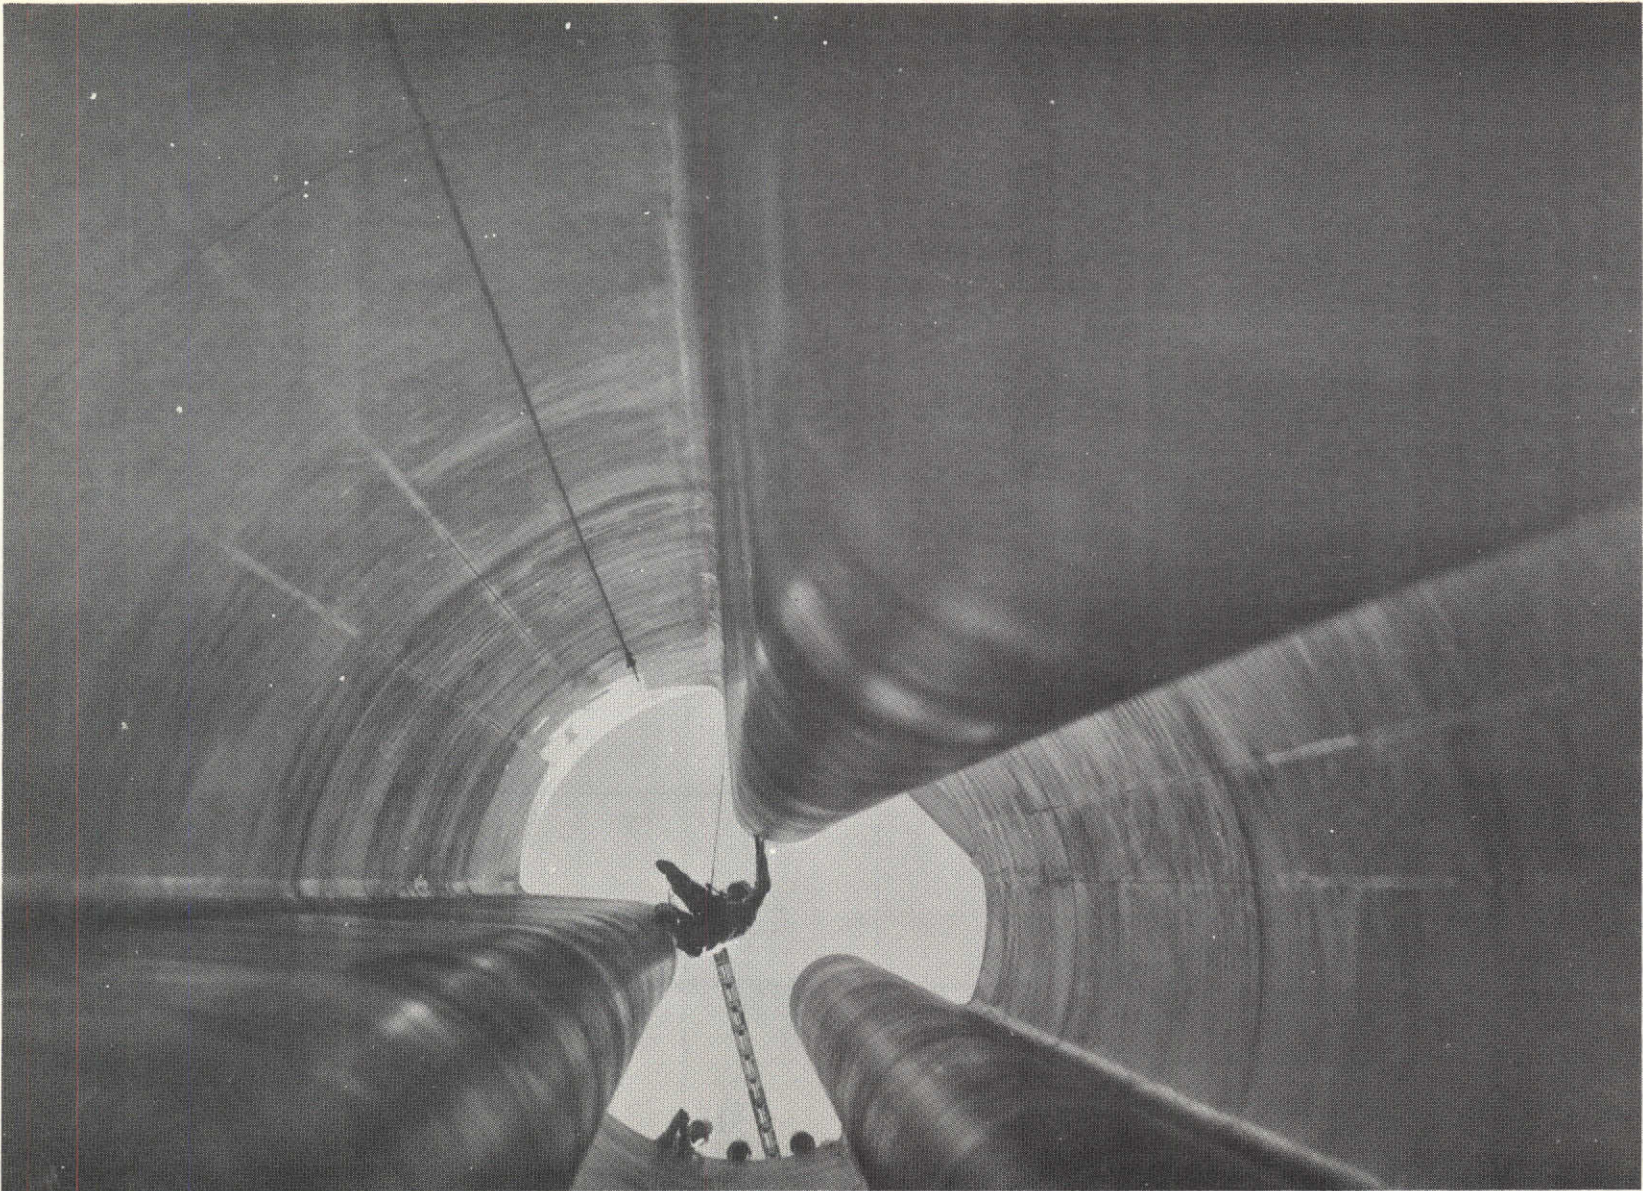
The core was removed from the grain on 21 January 1966; the net extraction force at core breakaway was 46,000 lb. Visual inspection of the grain bore surface showed that several small voids and blemishes were present; however, the surface appearance was satisfactory, with no evidence of structural deficiency. Figure 29 shows the grain bore after core removal.

Internal View of Grain Bore

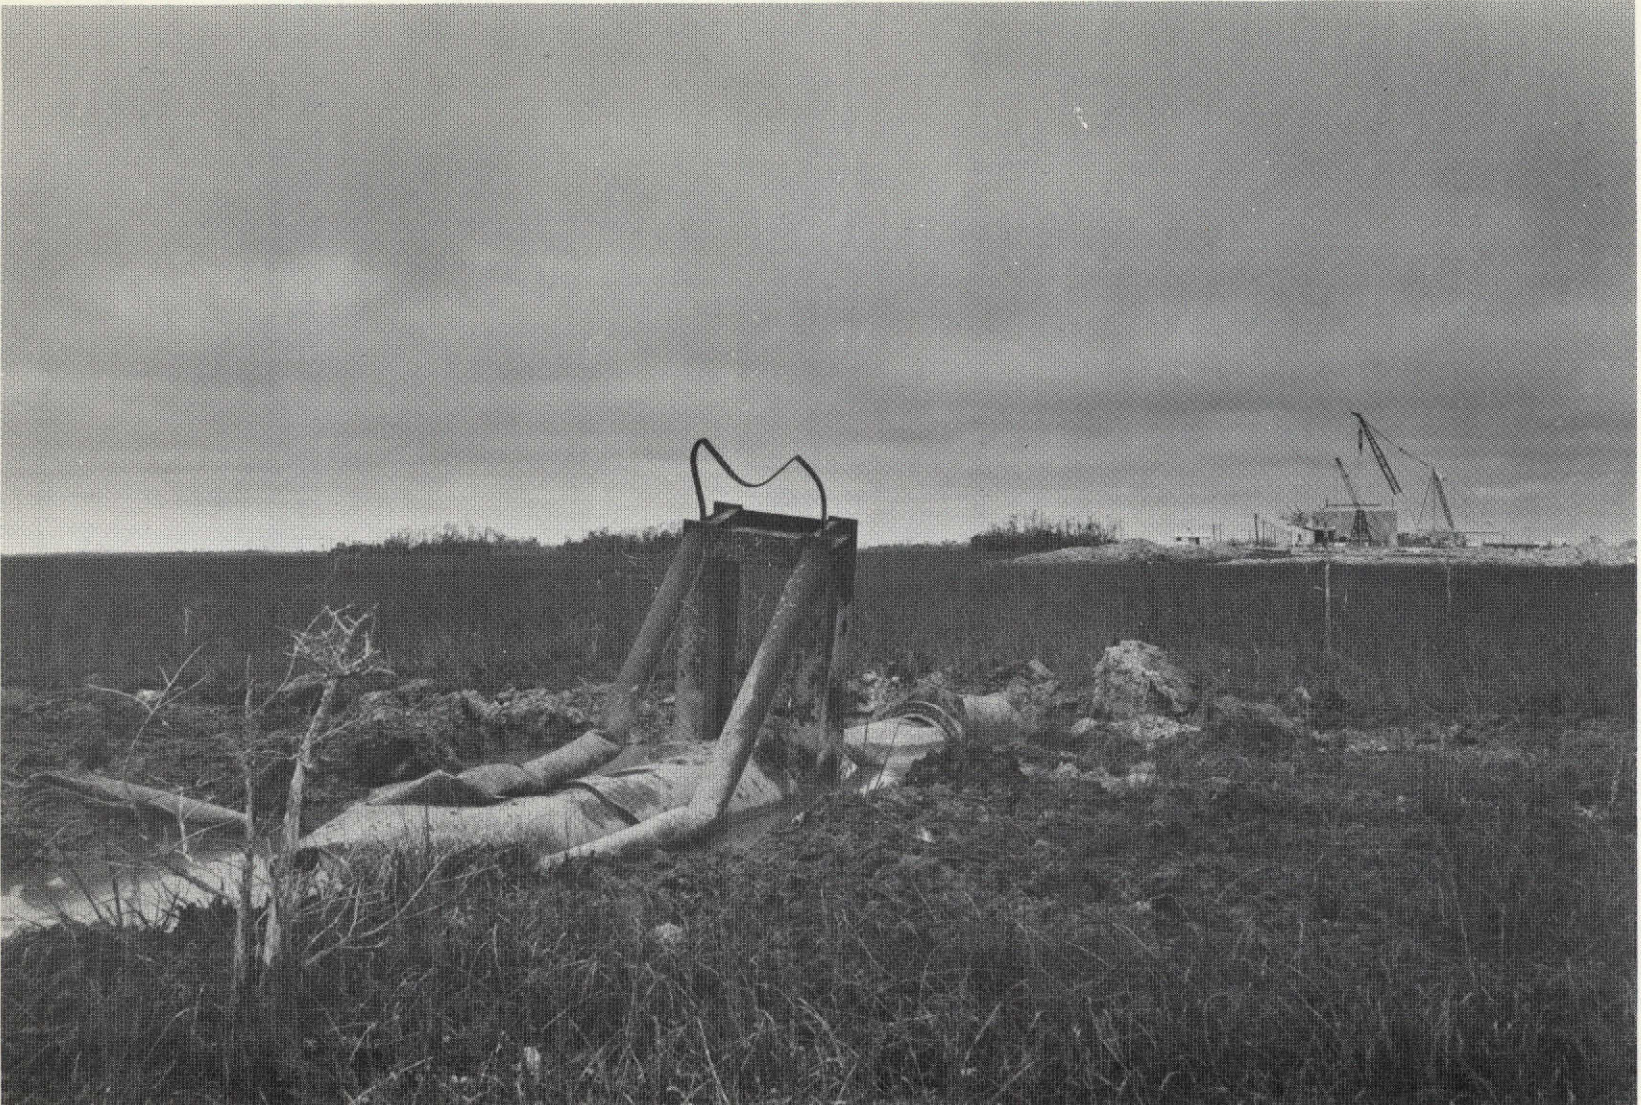
Posttest View of Ignition Motor and Sled Assembly

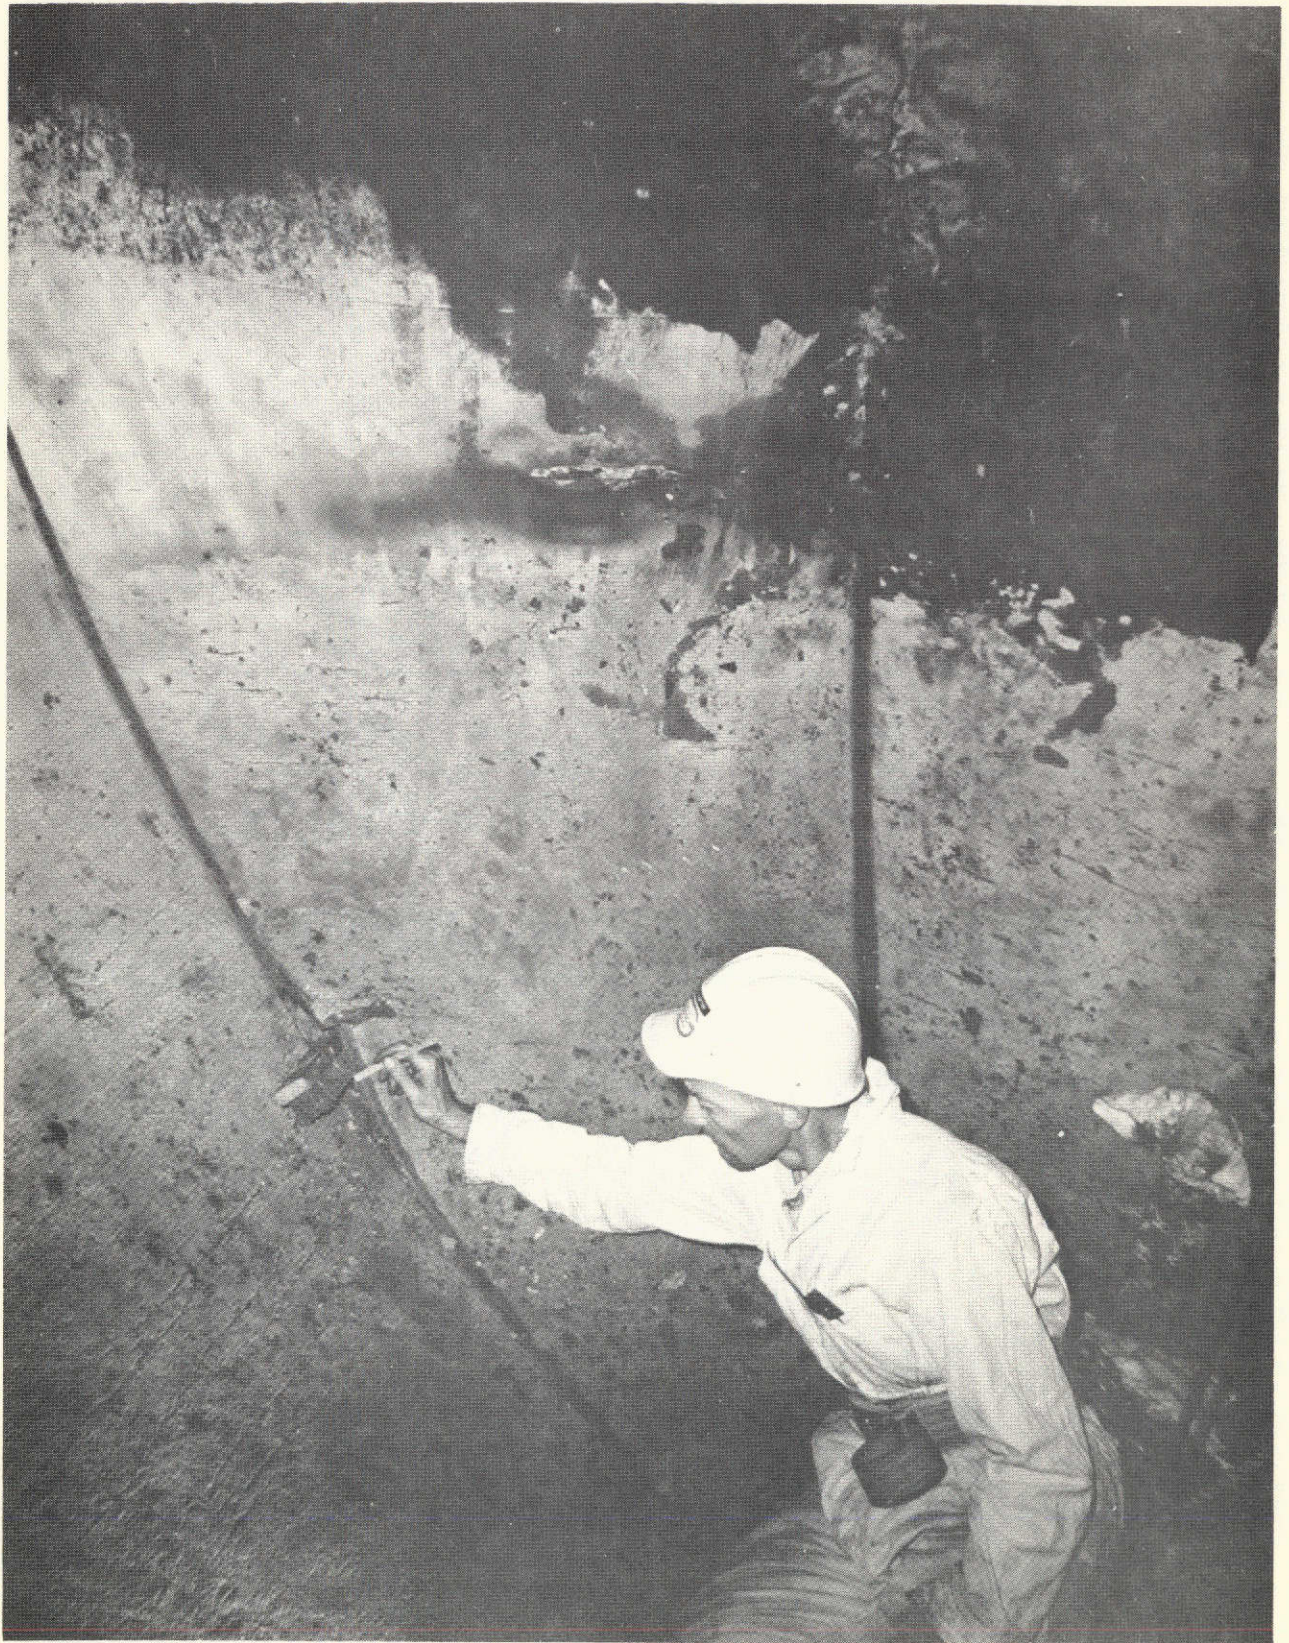
Figure 64

Posttest View of Forward Insulation

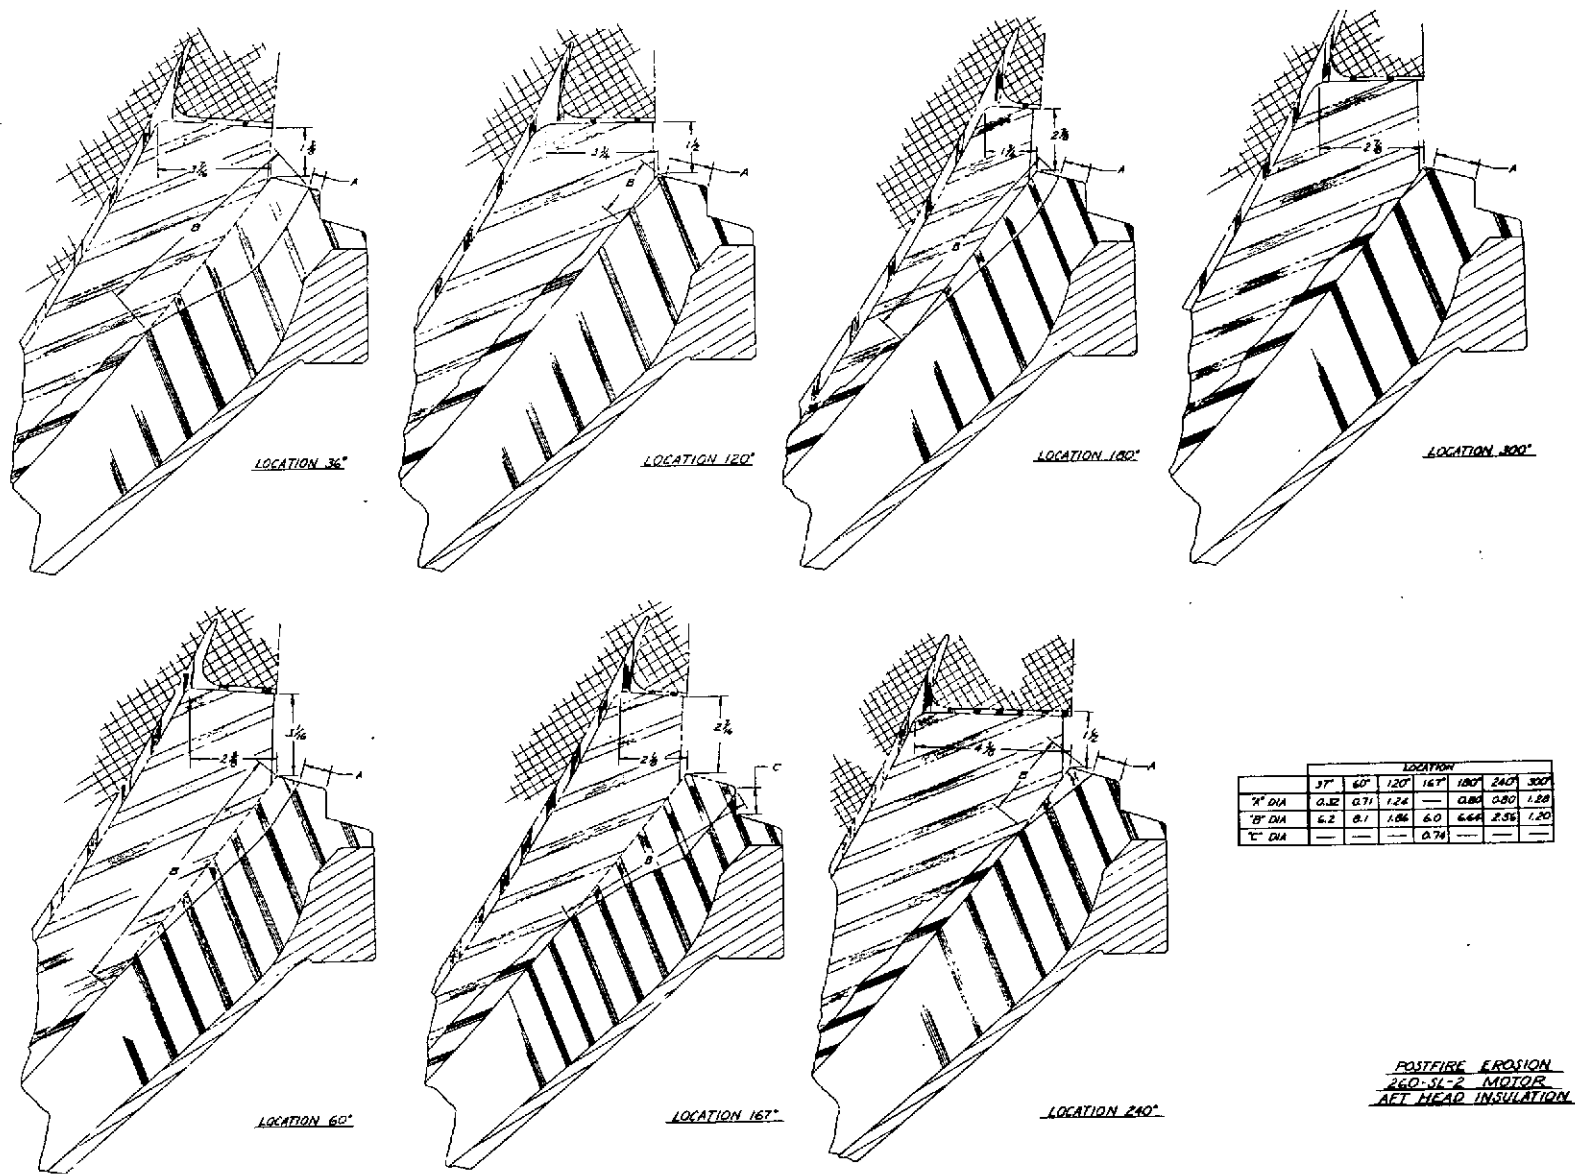
Figure 65

Posttest View of Aft Head Insulation

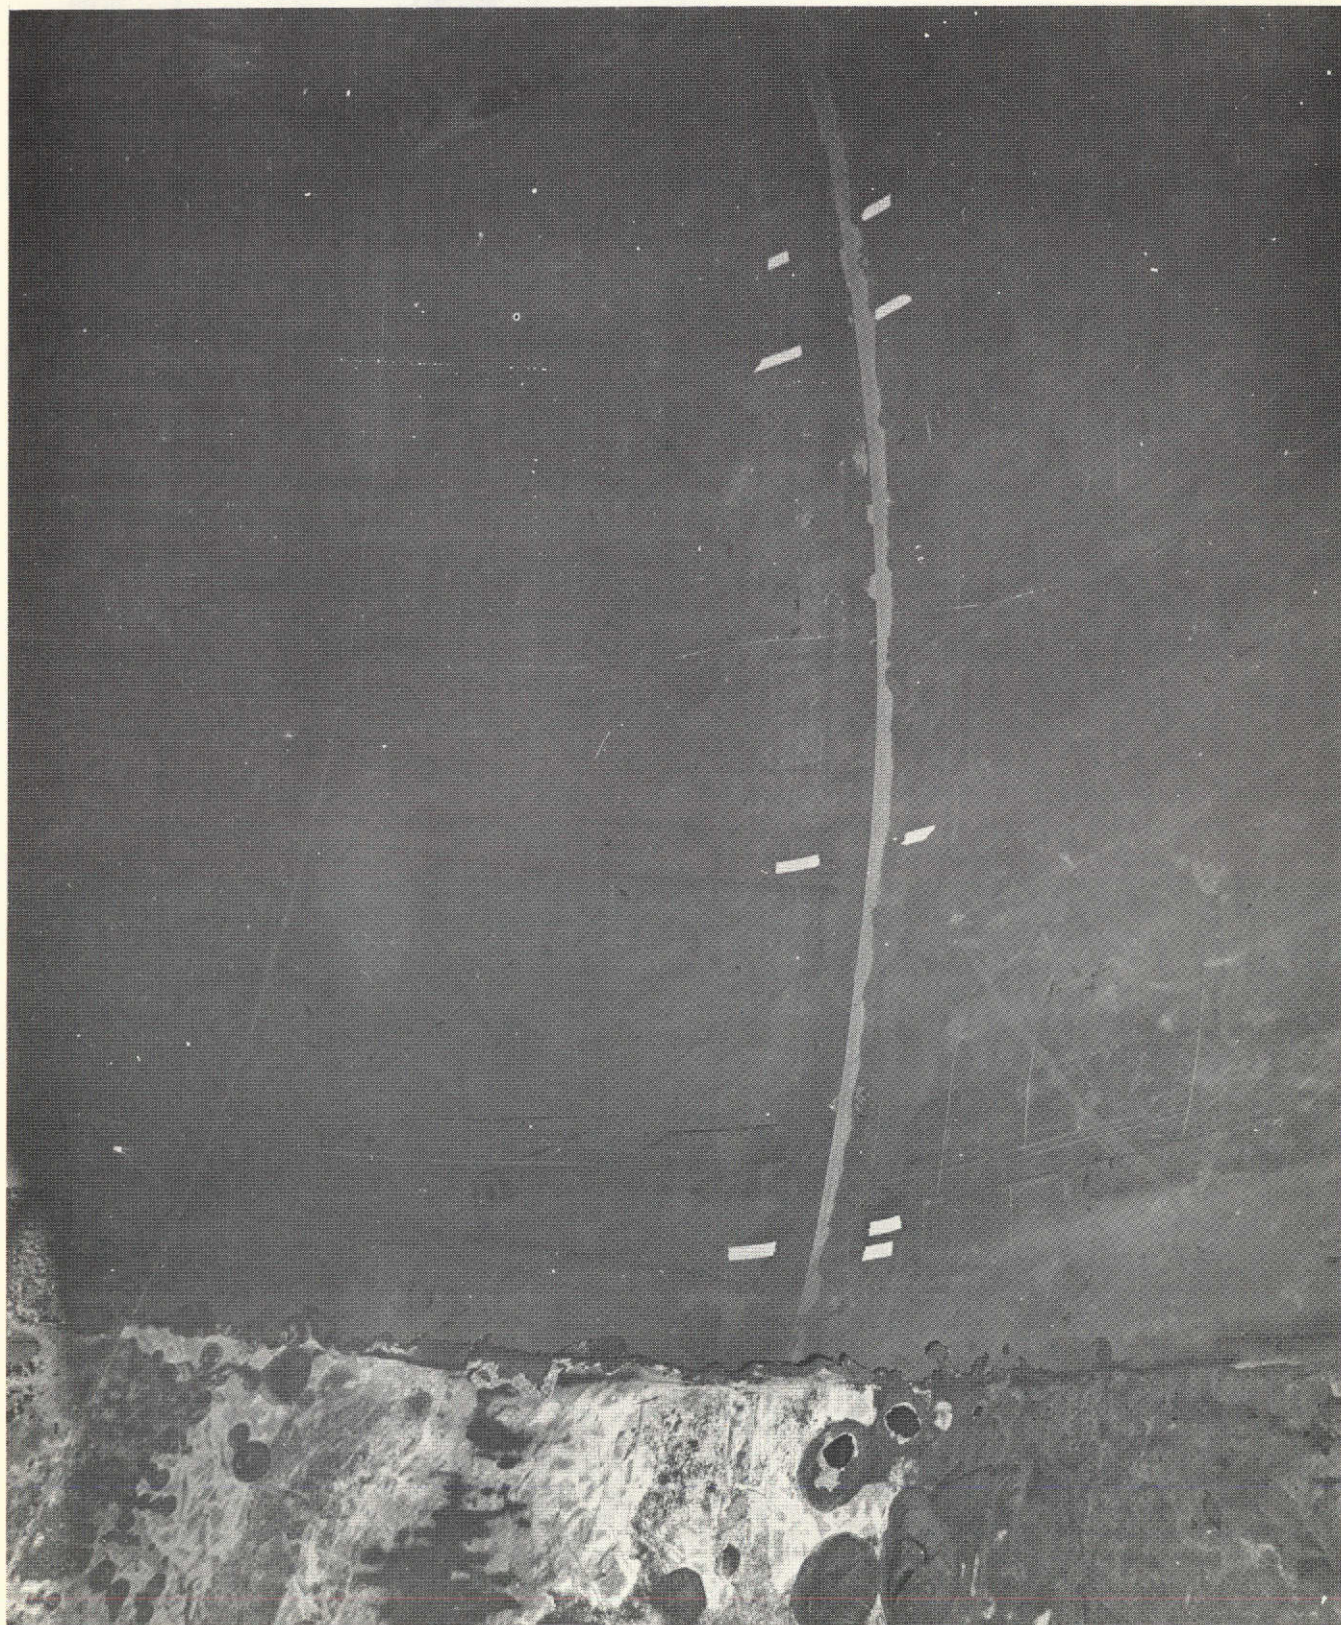
Posttest View of Aft Head Insulation with FMC-200 Potting Compound Removed .

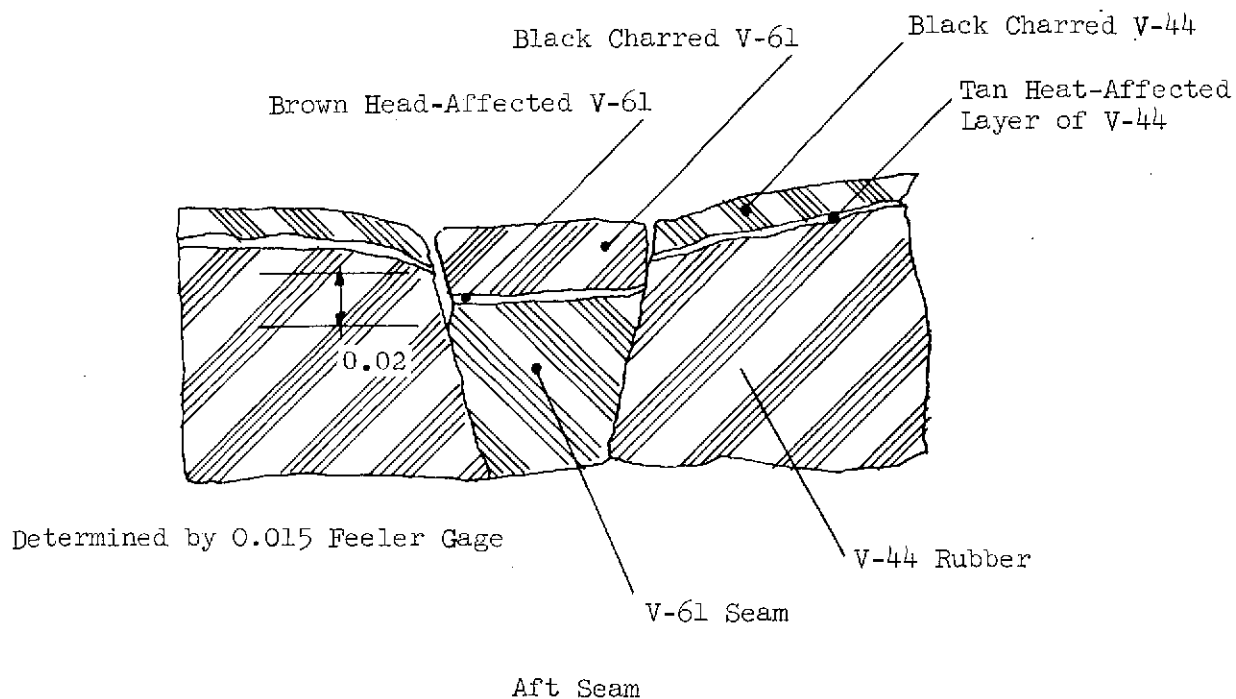
Posttest Condition of Motor 260-SL-2 Insulation Seams

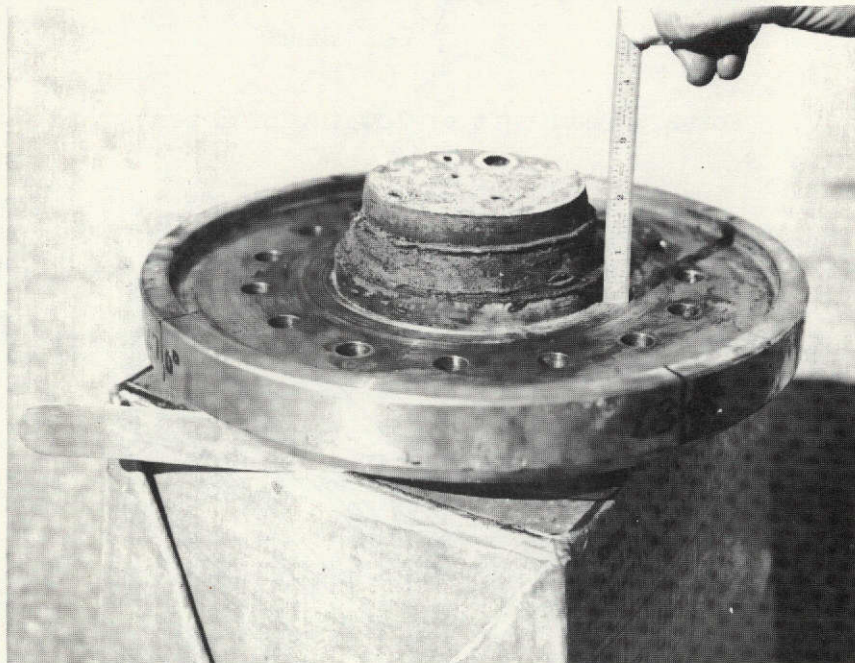
Posttest View of Firing Cap Insulation

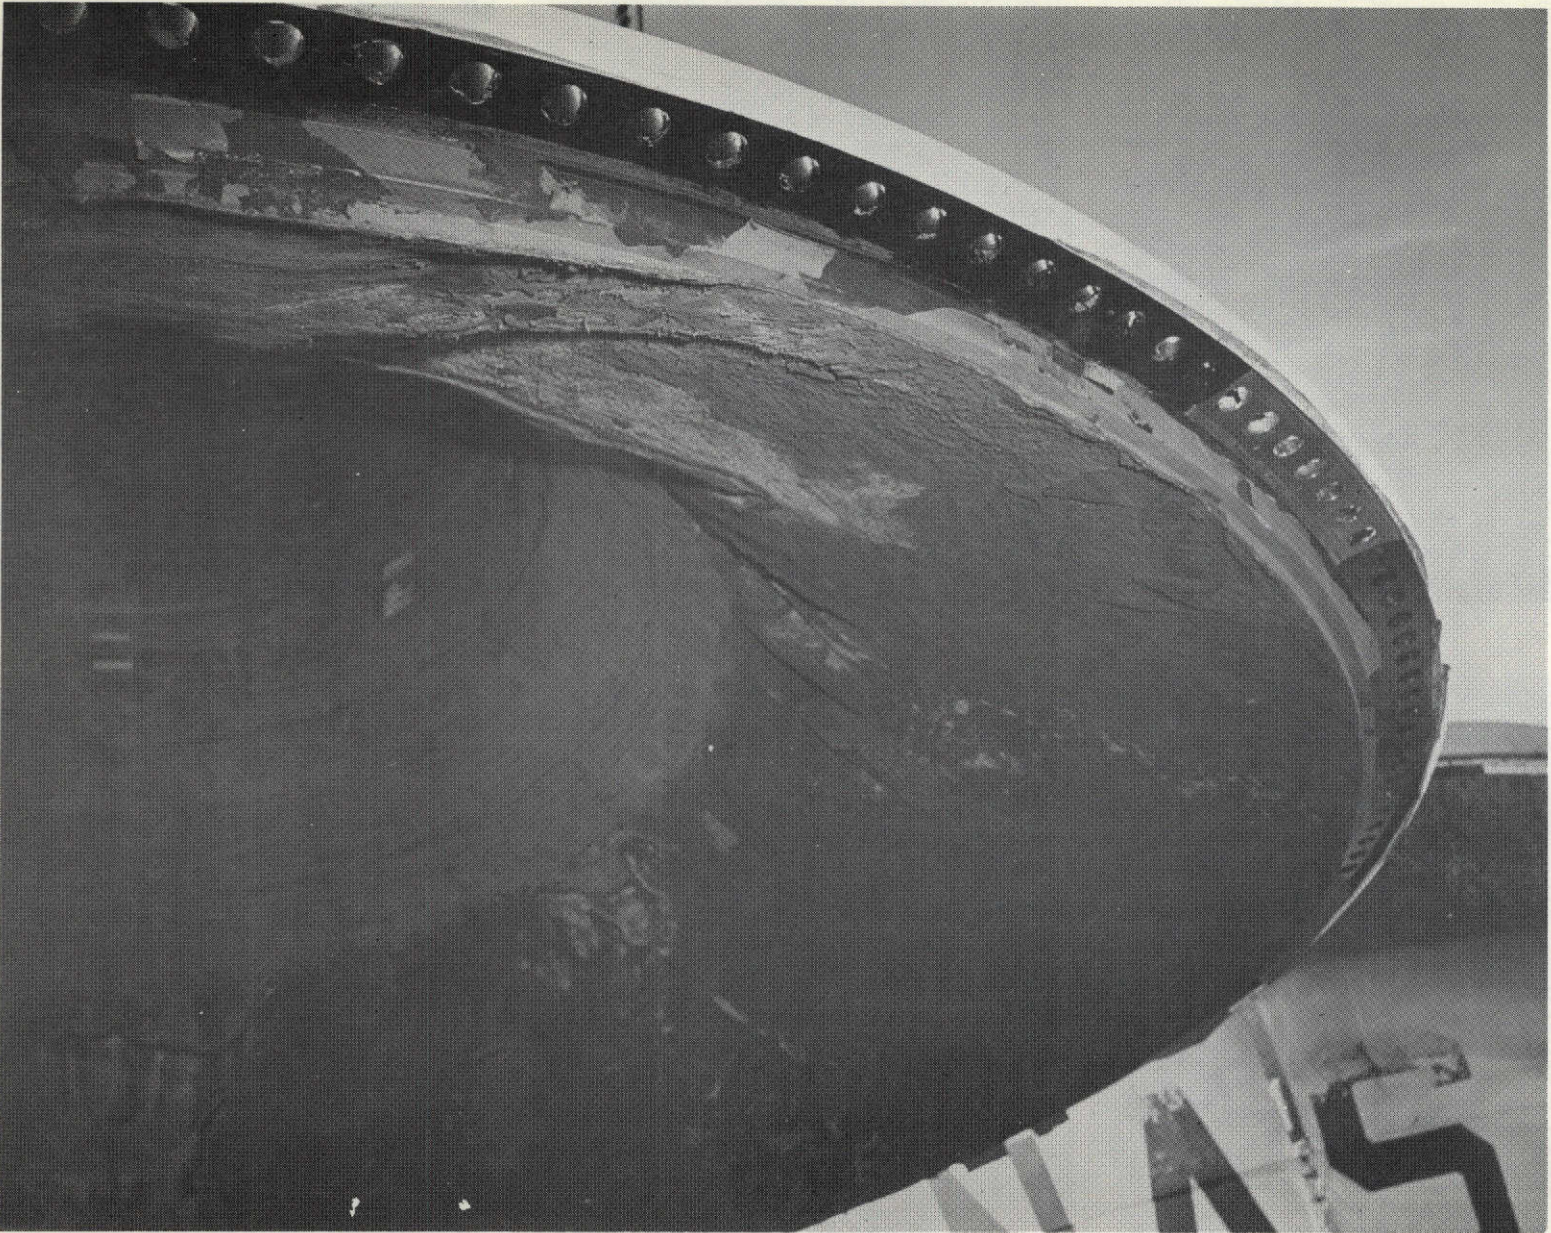
Posttest View of Nozzle Entrance Insert

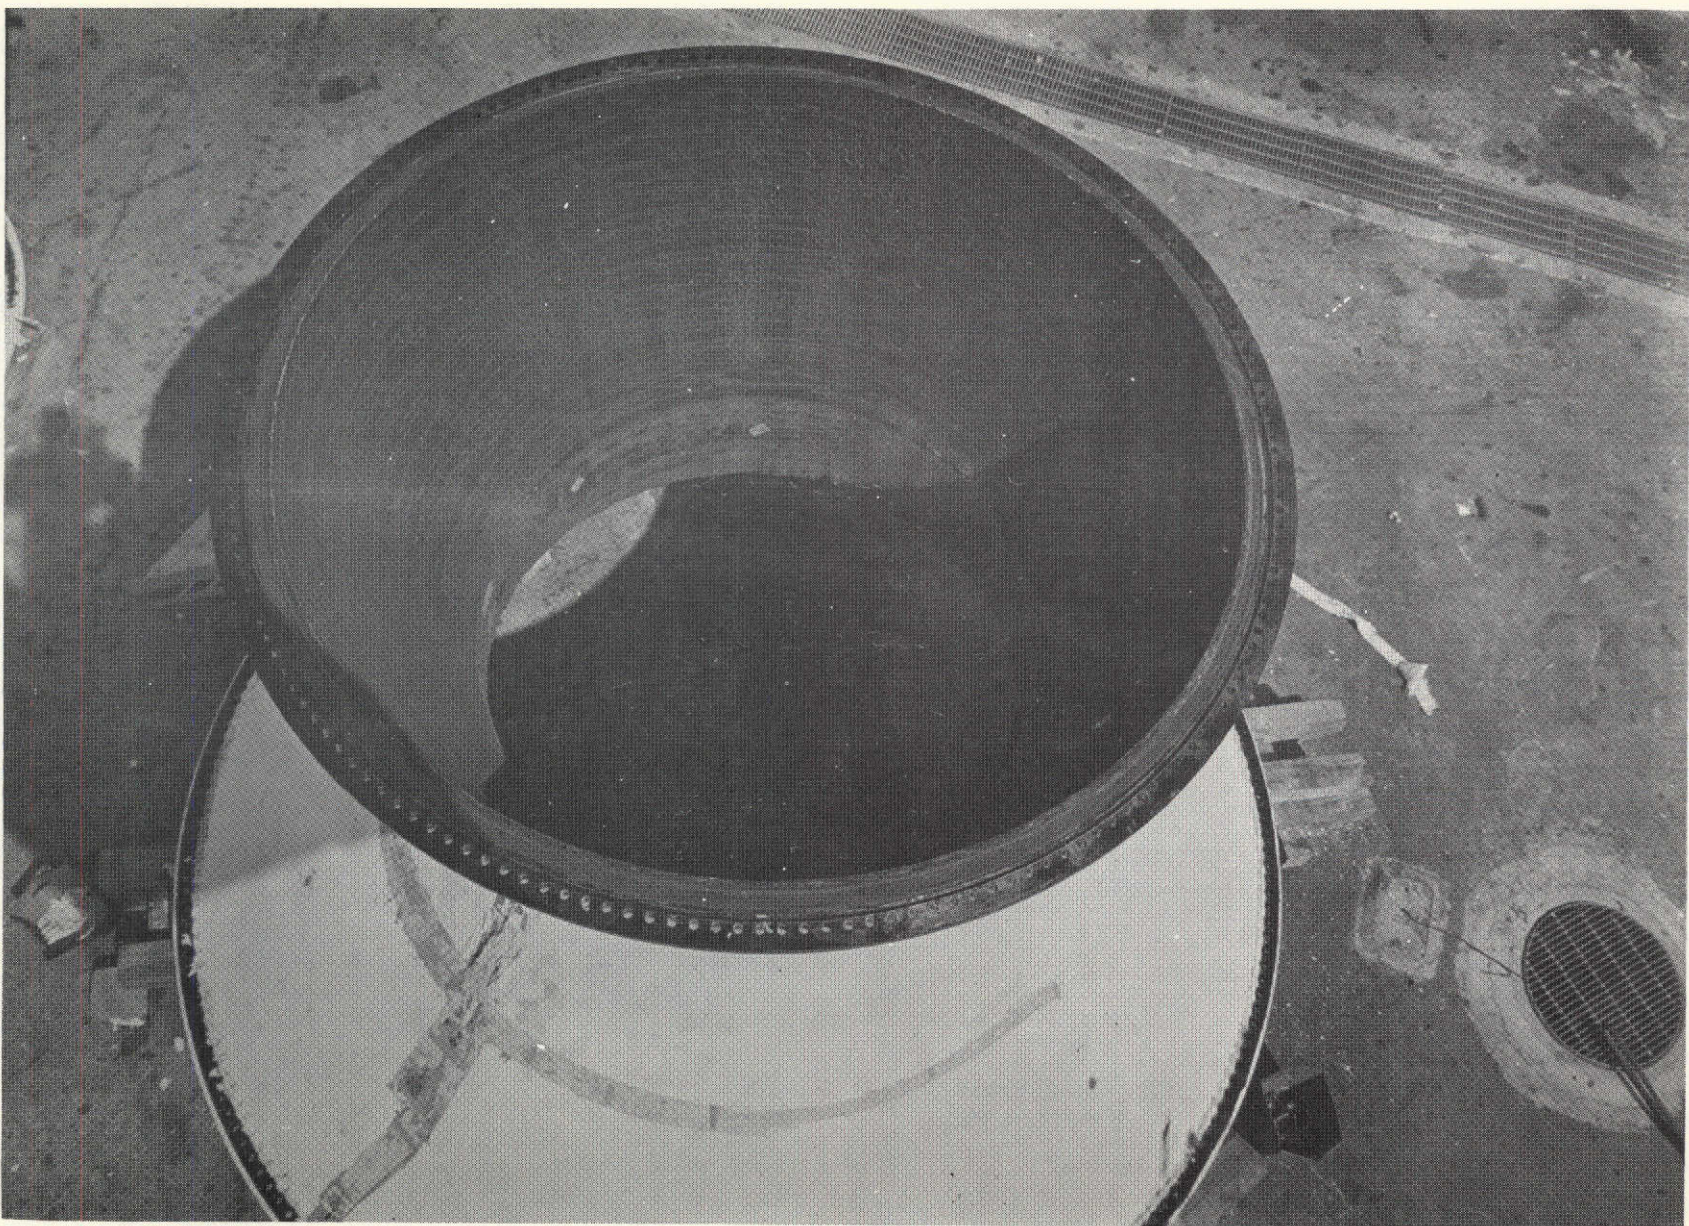
The structural integrity of the pressure vessel was maintained throughout the firing. There is no evidence that any gas leakage occurred or that abnormal loads were applied to any component. The internal insulation afforded adequate thermal protection. Structural integrity of the nozzle and exit cone was also maintained for the firing duration. Erosion performance of the nozzle rubber insulation and all ablative plastic liner components was very similar to that obtained in the firing of motor 260-SL-1. The average measured postfiring throat diameter was 1.25 in. greater than the prefiring diameter, which yields an average throat erosion rate of 4.8 mils/sec during motor action time.

Posttest View of Nozzle Throat Insert

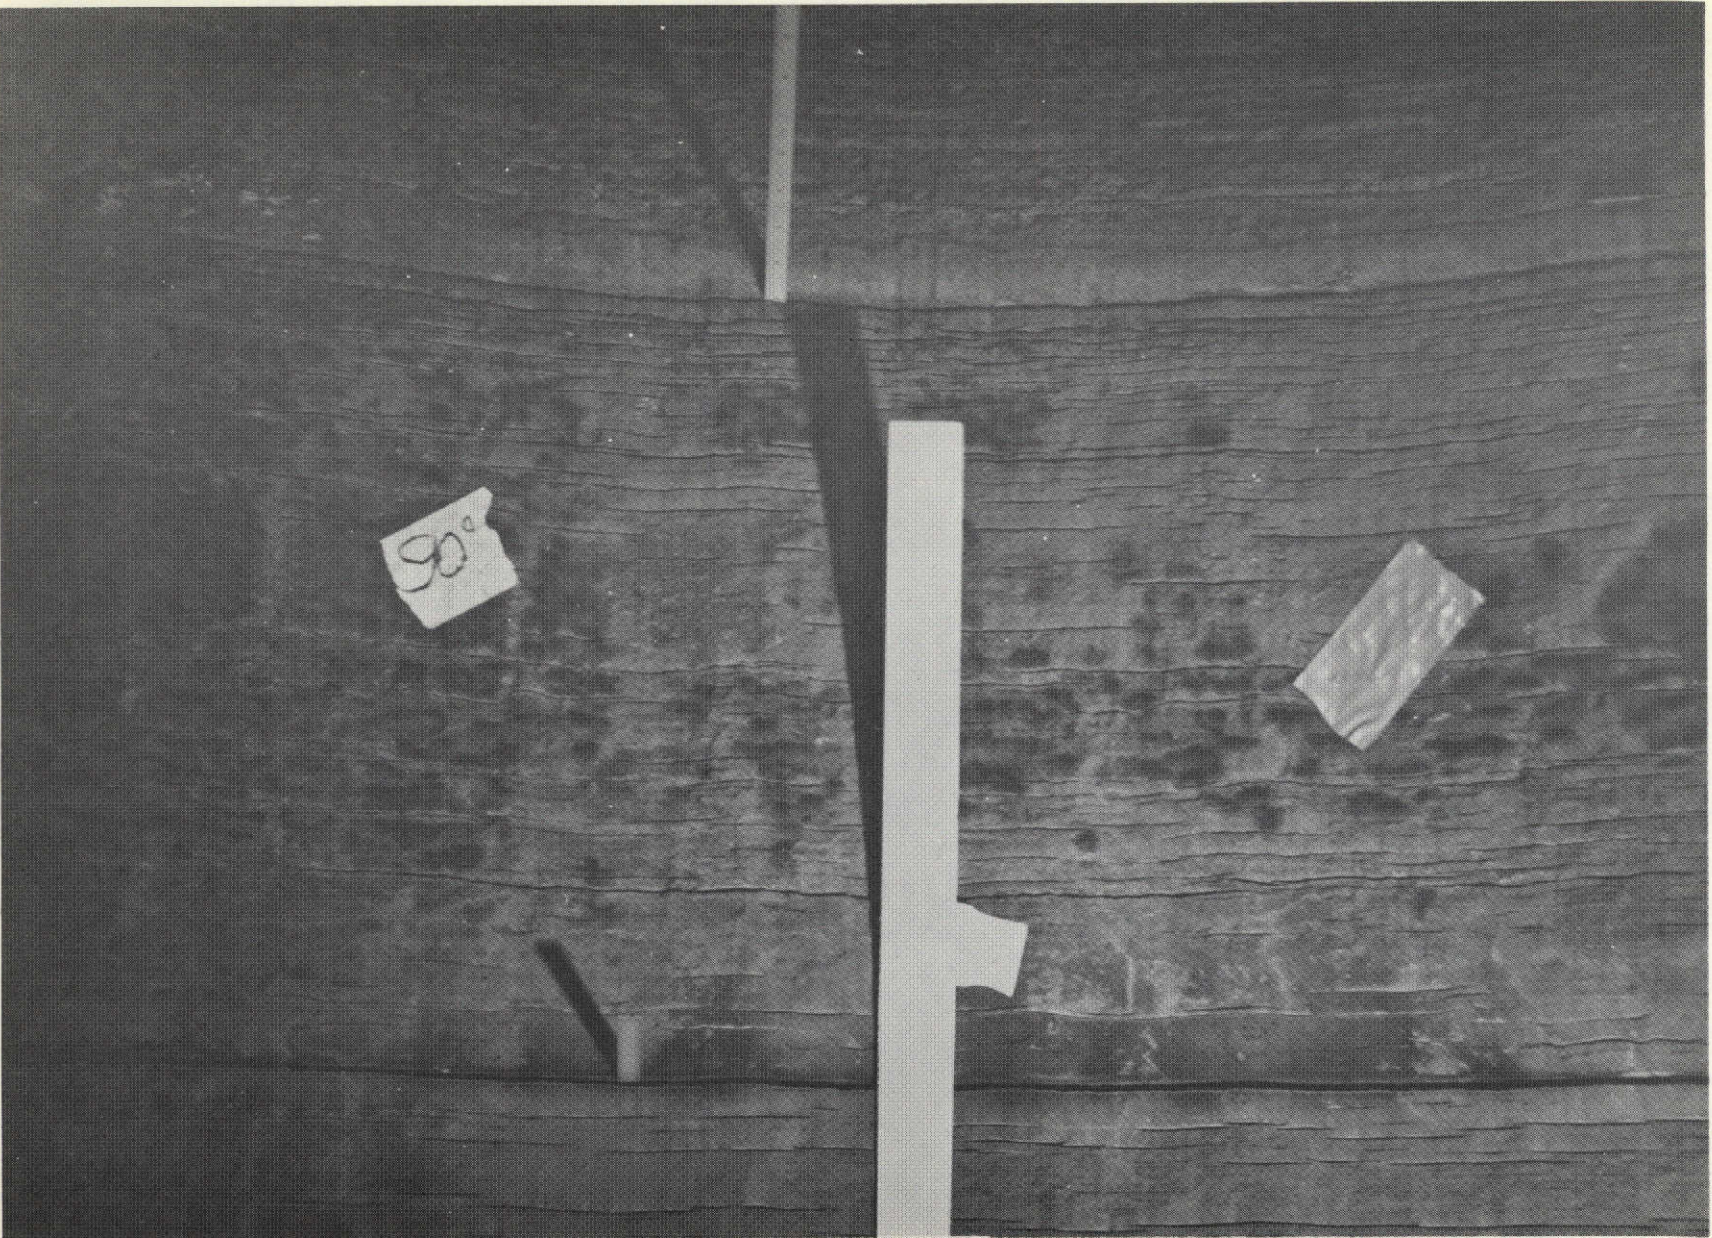
Posttest View of Nozzle Throat Insert Surface

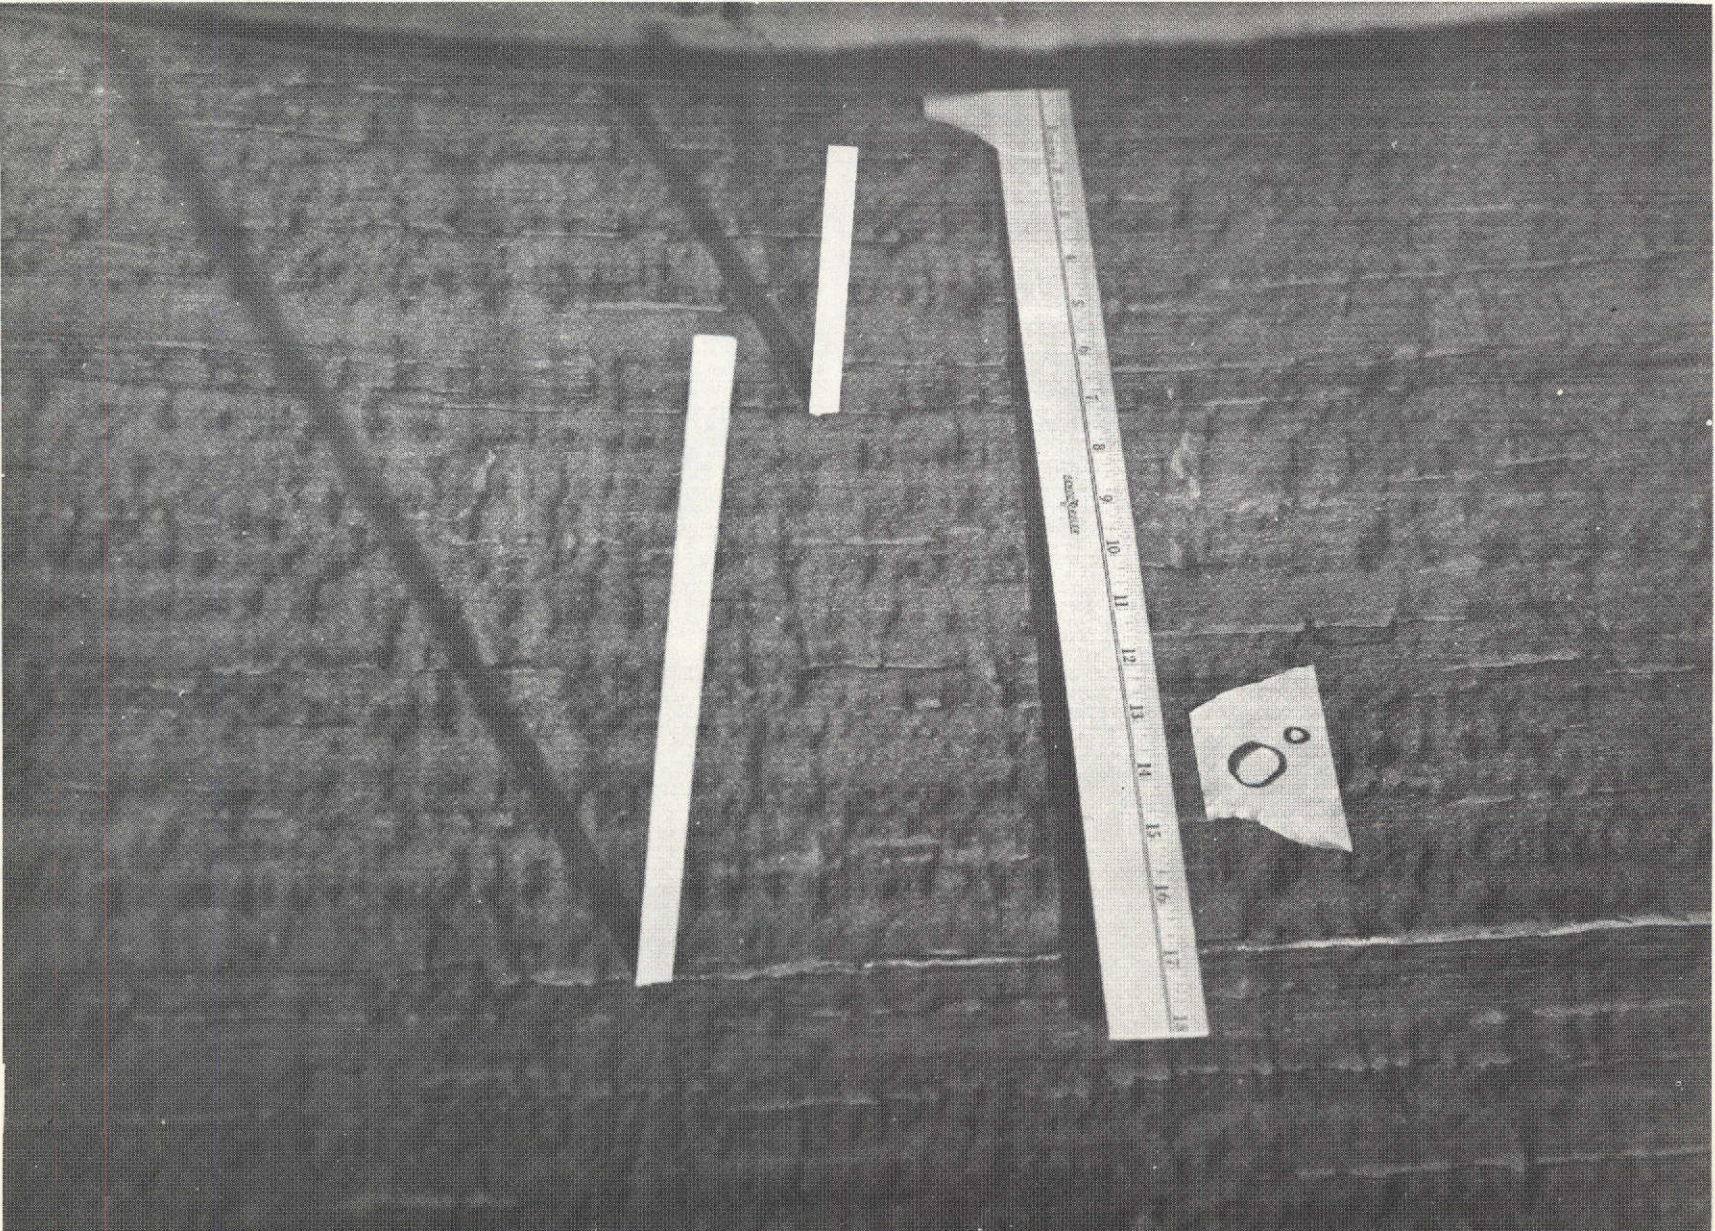
Posttest View of Nozzle Throat Extension Insert

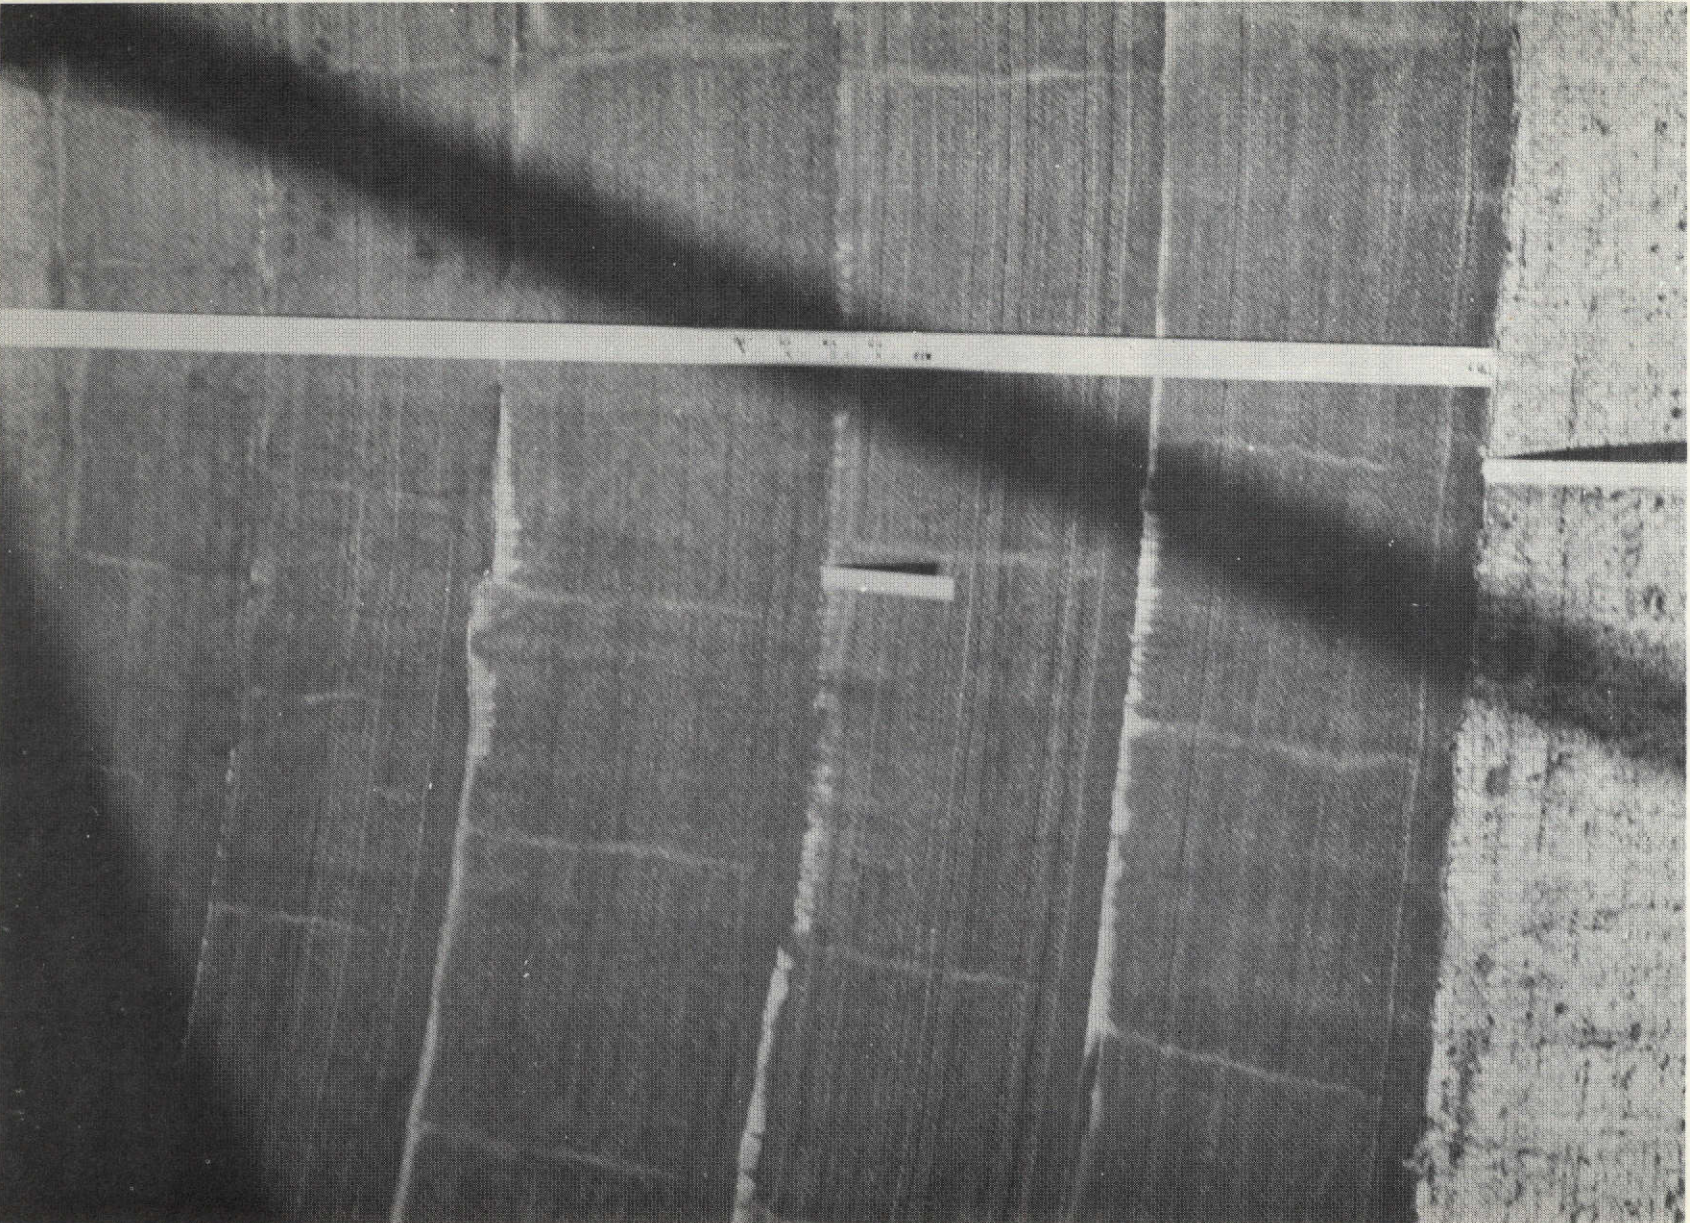
Posttest View of Exit Cone
